Comprehensive Report: 11 November 2022 Storm Event

1 DESCRIPTION OF MAJOR WORKS – 11 November 2022

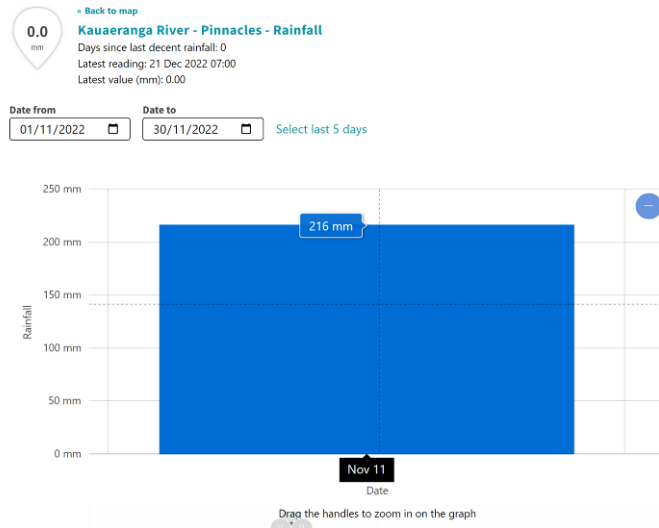
Data from the Waikato Regional Council rainfall gauge at the Pinnacles in the graph below shows in excess of 216mm in a 24 hour period on 11th November 22. This is a ARI of between 2-5 years however the rain gauges are quite some distance from the slip sites and there is no available rain gauge data nearby.

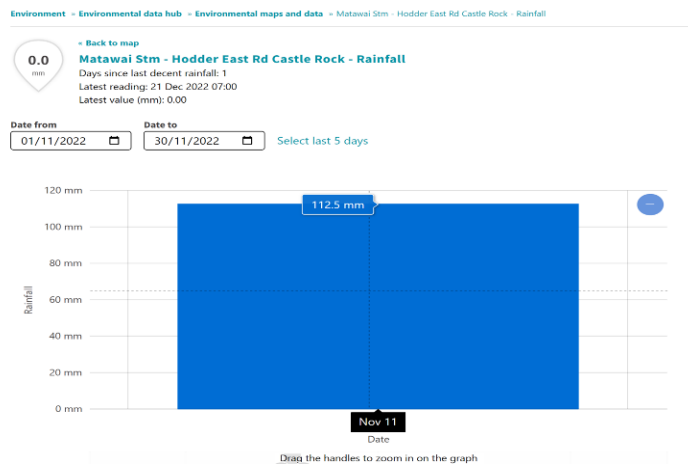
Data from the Waikato Regional Council rainfall gauge at Castle Rock in the graph below shows in excess of 112mm in a 24 hour period on 11th November 22. This is a ARI of less than 1.58 years however the rain gauges are quite some distance from the slip sites and there is no available rain gauge data nearby.

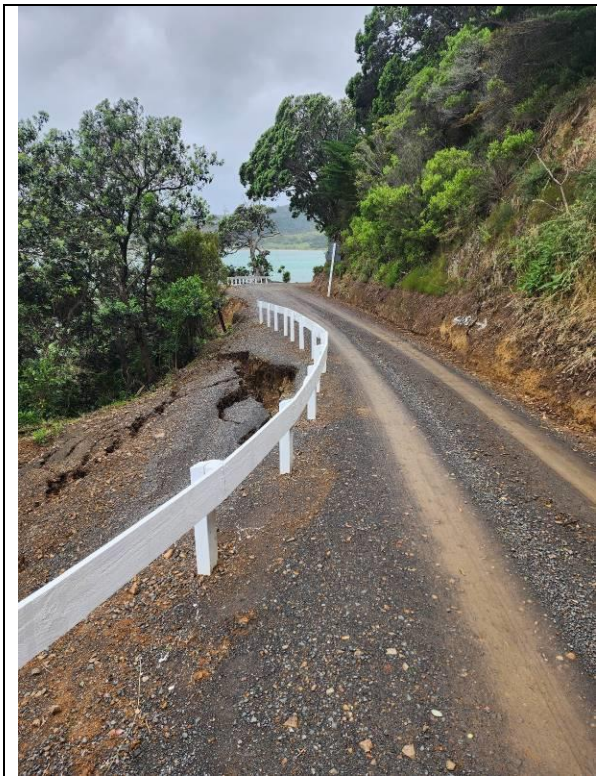
Wharf Road (Colville) – RP 1.58

Permanent Reinstatement site list & estimated Investigation & Design costs			
Road	Location & Issue	Investigation & Design Scope	Cost
Wharf Road (Colville)	RP1.58 – Underslip into traffic lane	Site Investigation & design and construction docs	\$40,000
Port Jackson Road	RP23.25 – Underslip into traffic lane	Site Investigation & boreholes, design and construction docs	\$50,000
Port Jackson	RP22.02 – Underslip	Site Investigation &	\$40,000

Permanent Reinstatement site list & estimated construction & MSQA costs			
Road	Location & Issue	Permanent Repair	Cost
Wharf Road (Colville)	RP1.58 – Underslip into traffic lane	Rock Wall	\$350,000
Port Jackson Road	RP23.25 – Underslip into traffic lane	Rock wall or post/panel	\$250,000
Port Jackson Road	RP22.02 – Underslip into traffic lane	TBC Based on ground conditions	\$250,000
Blackjack Road	RP0.07 – Underslip with cracking in traffic lane	Rock Wall	\$200,000
Total Physical works permanent reinstatement			\$1,050,000
Professional Services			
Contract Tendering & Admin and MSQA Costs			\$100,000
Total Professional Services			\$100,000
Total Permanent Reinstatement			\$1,150,000

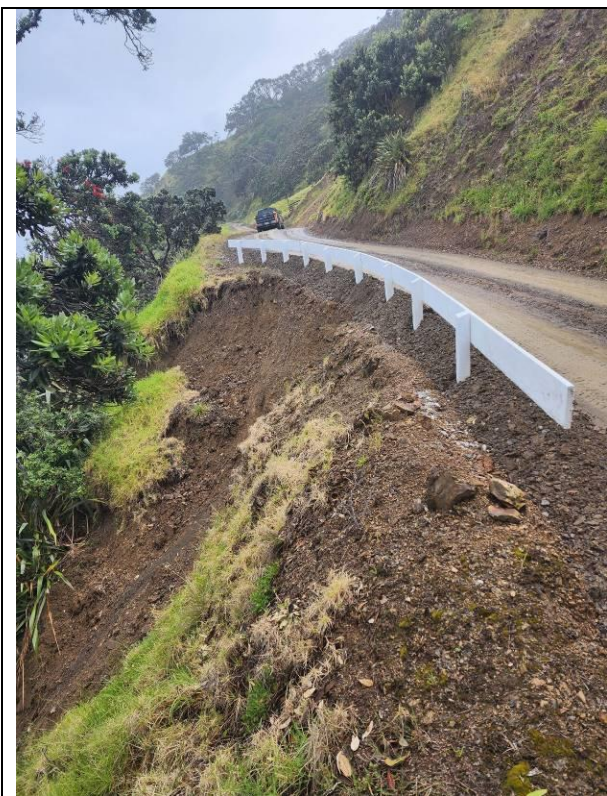
Port Jackson Road – RP 22.02

Road	into traffic lane	boreholes, design and construction docs	
Blackjack Road	RP0.07 – Underslip with cracking in traffic lane	Site Investigation & design and construction docs	\$30,000
Total Phase 1 Investigation/Design Professional Services			\$160,000
